**REPORT ON THE TYPE THREE DESTRUCTIVE
SURVEY TO LOCATE AND ASCERTAIN THE NATURE
OF SUSPECTED ASBESTOS BASED MATERIALS**

**THE PERIWINKLE PUBLIC HOUSE
Aldham House Lane
Wombwell
South Yorkshire
S73 8RG**

**Dated: 2nd December 2009
REPORT No: ASC/SUR/CS/0097**

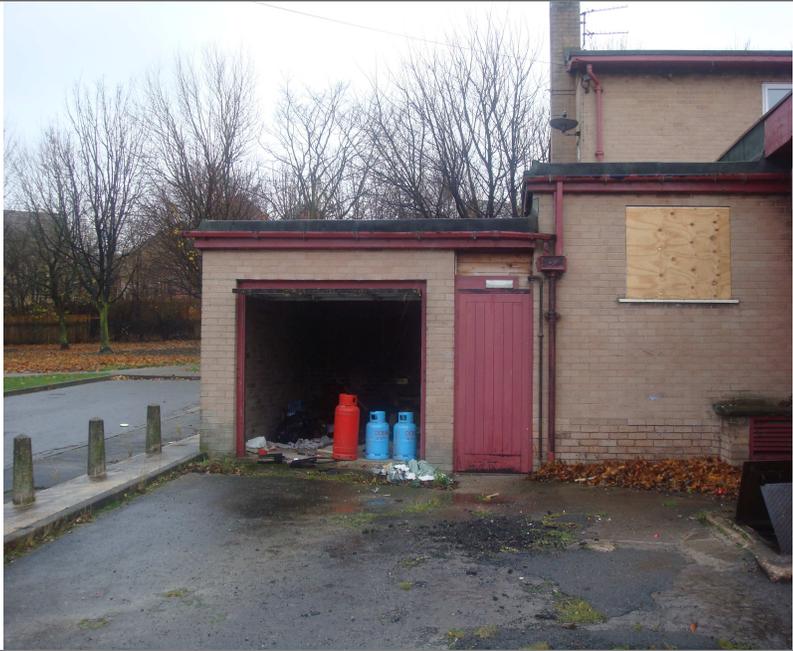
Sample Location: GB/01/01 - Garage Block – Roof Lining Panels

A sample taken from the above reference location has been found to contain Amosite / Chrysotile asbestos.

The materials are on the whole in good condition having received only minor damage at time of survey.

Site:	The Periwinkle PH, Aldham House Lane, Wombwell S73 8RG
Building:	Garage Block
Floor:	Ground Floor
Room/Area:	Garage

Component:	Insulation Boarding	Sample No:	GB/01/01
Sampled By:	C Stephenson	Asbestos:	AMOSITE / CHRYSOTILE

Condition:	Fair

Friability:	Low		
Surface Treatment:	None		
Position:	Internal		
Accessibility:	Low		
Exposure:	Maintenance		
Room/Area Size:	N/A		
Approx. Amount of Material at Location:	20 sq.m		
Photo Number:	001		Action Priority:

Comments:	Asbestos Insulation Board panels forming the internal roof lining boarding to the garage roof and adjacent fire escape corridor
Recommendation:	Remove prior to demolition / refurbishment

Prior to any demolition works all Asbestos Insulation Boarding (AIB) should be removed by a licensed asbestos removal contractor under fully controlled conditions in accordance with the *Control of Asbestos Regulations 2006*.

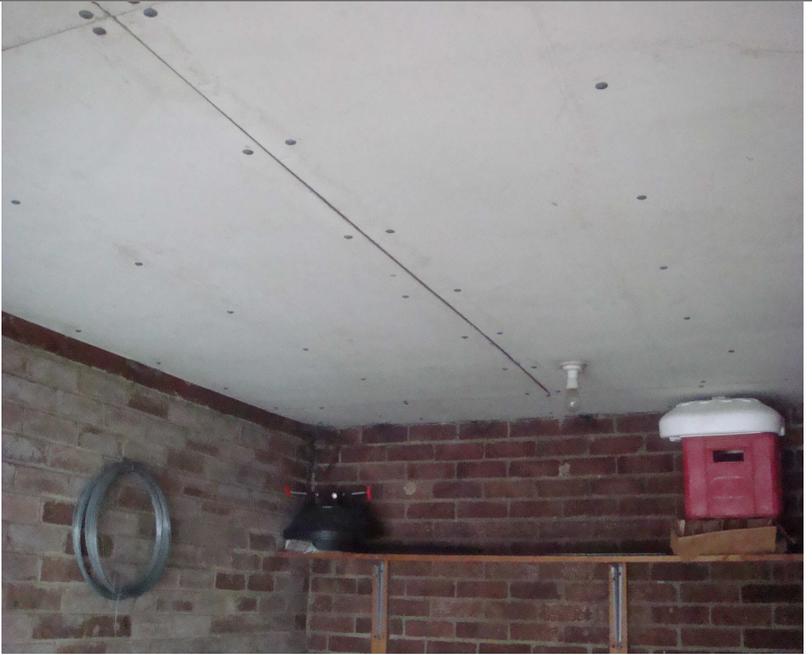
Site:	The Periwinkle PH, Aldham House Lane, Wombwell S73 8RG
Building:	Garage Block
Floor:	Ground Floor
Room/Area:	Garage

Component:	Insulation Boarding	Sample No:	GB/01/01
Sampled By:	C Stephenson	Asbestos:	AMOSITE / CHRYSOTILE

Condition:	Fair

Friability:	Low		
Surface Treatment:	None		
Position:	Internal		
Accessibility:	Low		
Exposure:	Maintenance		
Room/Area Size:	N/A		
Approx. Amount of Material at Location:	20 sq.m		
Photo Number:	002	Action Priority:	N/A

Comments:	Asbestos Insulation Board panels forming the internal roof lining boarding to the garage roof and adjacent fire escape corridor
Recommendation:	Remove prior to demolition / refurbishment

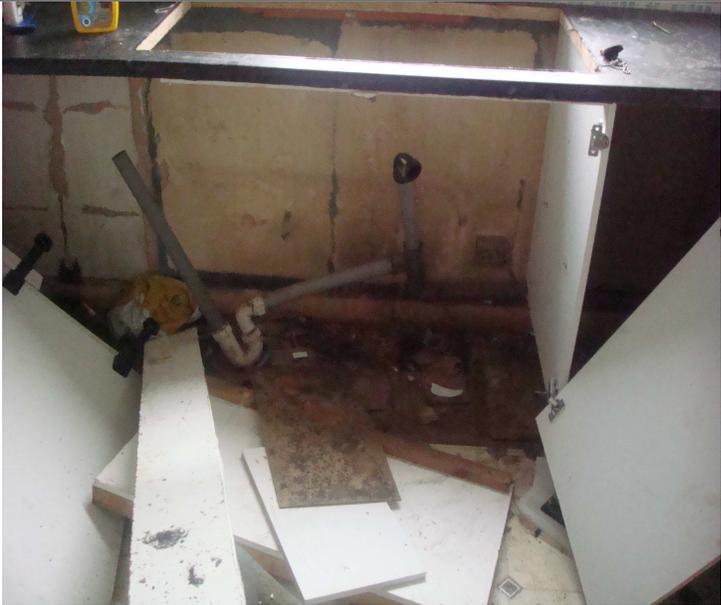
Sample Location: SA/01/01 & SA/02/01 – Staff Accommodation – Kitchen & Stairwell – Thermoplastic Flooring – Cream Coloured

The samples of the bonded thermoplastic materials used as flooring within the above areas of the first floor staff accommodation have been found to contain Chrysotile (White asbestos).

Site:	The Periwinkle PH, Aldham House Lane, Wombwell S73 8RG
Building:	Main Block
Floor:	First Floor
Room/Area:	Kitchen

Component:	Thermoplastic Tiles	Sample No:	SA/01/01
Sampled By:	C Stephenson	Asbestos:	CHRYBOTILE

Condition:	Fair

Friability:	Low		
Surface Treatment:	None		
Position:	Internal		
Accessibility:	Low		
Exposure:	Maintenance		
Room/Area Size:	N/A		
Approx. Amount of Material at Location:	10 sq.m		
Photo Number:	003	Action Priority:	N/A

Comments:	Asbestos containing thermoplastic floor tiles within the Kitchen area of the staff accommodation. Cream coloured.
Recommendation:	Remove prior to demolition / refurbishment

The *Control of Asbestos Regulations 2006* does not require the use of a licensed asbestos removal contractor for the removal of asbestos containing thermoplastic products. However they do require them to be disposed of as asbestos waste and for the removal to be carried out under controlled conditions, due to the possibility of airborne fibre release.

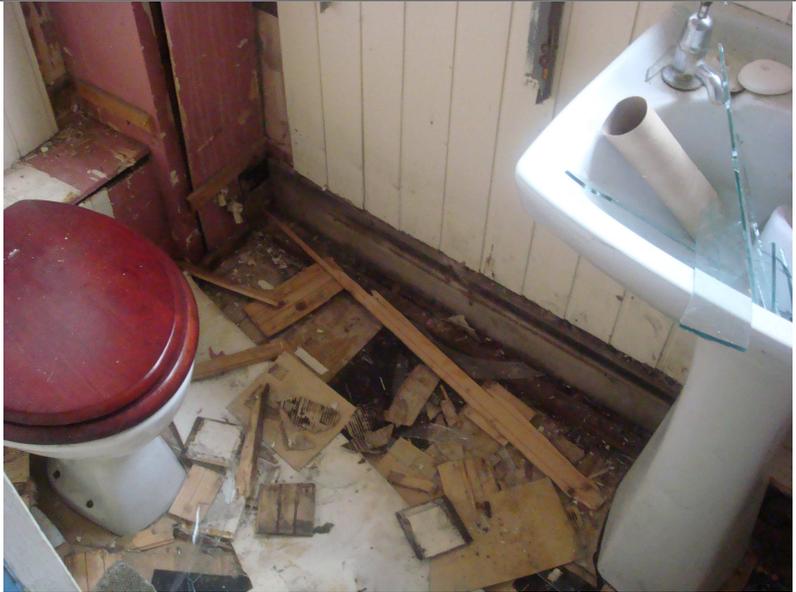
Site:	The Periwinkle PH, Aldham House Lane, Wombwell S73 8RG
Building:	Main Block
Floor:	First Floor
Room/Area:	Staff Accommodation Stairwell

Component:	Thermoplastic Tiles	Sample No:	SA/02/01
Sampled By:	C Stephenson	Asbestos:	CHRYBOTILE

Condition:	Fair

Friability:	Low		
Surface Treatment:	None		
Position:	Internal		
Accessibility:	Low		
Exposure:	Maintenance		
Room/Area Size:	N/A		
Approx. Amount of Material at Location:	5 sq.m		
Photo Number:	004	Action Priority:	N/A

Comments:	Asbestos containing thermoplastic floor tiles within the Kitchen area of the staff accommodation. Cream coloured.
Recommendation:	Remove prior to demolition / refurbishment

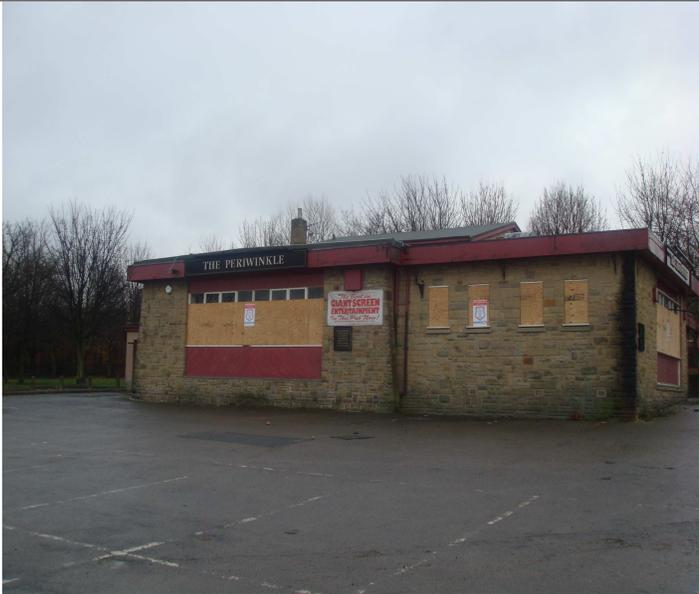
Sample Location: No Sample - Front Block – Roof Level External Walkways – Promenade Tiles

A visual examination has been made of the walkway tiles (access restricted due to damaged roof structure). In the opinion of the surveyor the material is asbestos containing cement and by default the asbestos content is stated as being Crocidolite and Chrysotile (blue and white asbestos).

Site:	The Periwinkle PH, Aldham House Lane, Wombwell S73 8RG
Building:	Main Block
Floor:	External
Room/Area:	Roof Level above Front Bar Area

Component:	Cement Tiles	Sample No:	No sample
Sampled By:	C Stephenson	Asbestos:	CROCIDOLITE/CHRYSTOLE

Condition:	Fair

Friability:	Low		
Surface Treatment:	None		
Position:	External		
Accessibility:	Low		
Exposure:	Maintenance		
Room/Area Size:	N/A		
Approx. Amount of Material at Location:	10 sq.m		
Photo Number:	005	Action Priority:	N/A

Comments:	Asbestos containing external promenade tiles.
Recommendation:	Remove prior to demolition / refurbishment

The *Control of Asbestos Regulations 2006* does not require the use of a licensed asbestos removal contractor for the removal of asbestos cement products. However they do require asbestos cement to be disposed of as asbestos waste and for the removal to be carried out under controlled conditions, due to the possibility of airborne fibre release.

Those undertaking the removal works should produce a written method statement and risk assessment prior to undertaking the work. It may therefore be prudent to employ a licensed contractor, as they have the relevant experience and equipment for works of this type.
